CLASSIC YACHT MARINE SURVEYORS

Report of Marine Survey

Time Out

1981 32' Trogan F-32

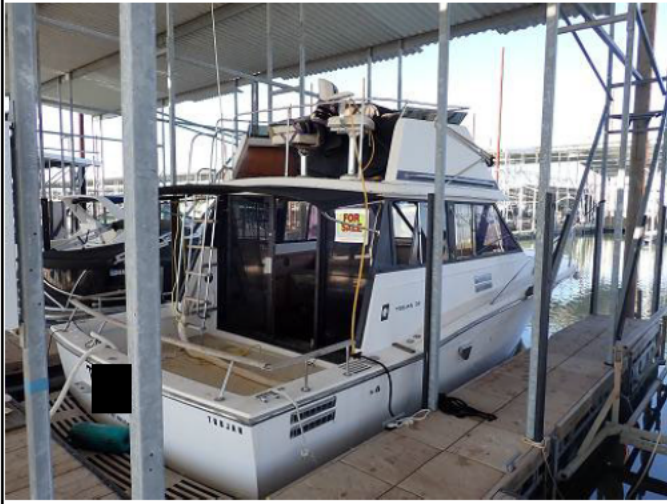
Starboard side view of "Time Out"

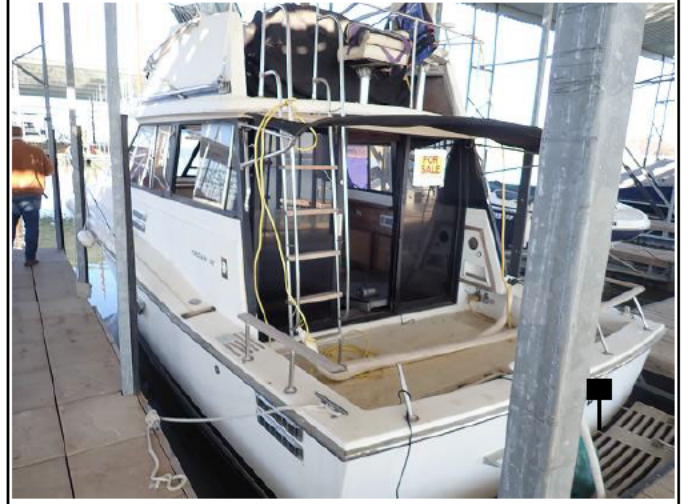
Port side view of "Time Out"

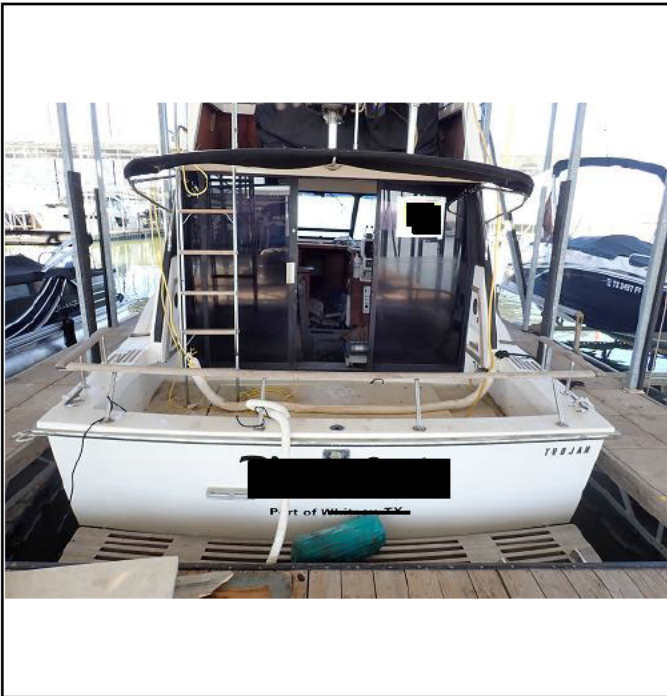
"Time Out" Transom View

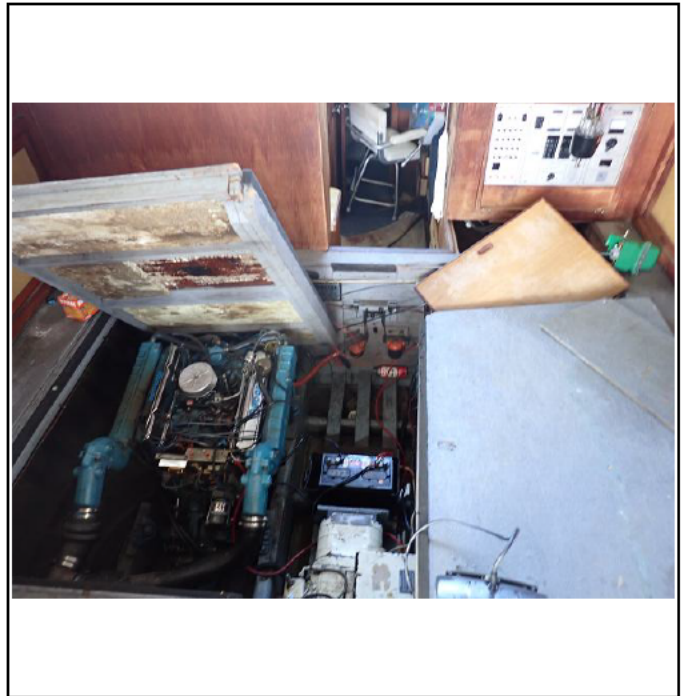
Overhead view of the port engine.

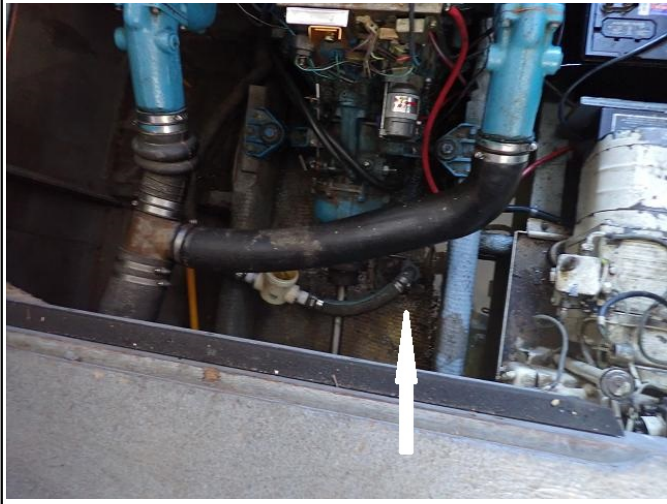
All valves connected to the thru-hull fittings were of the gate valve type located throughout the boat and were in the closed position. Marina manager said that the Boat US Lewisville salvage team shut off all seacocks on the day of the reported sinking. The boat has not taken on water since then.

Port Engine Raw Water Seacock in the closed position.

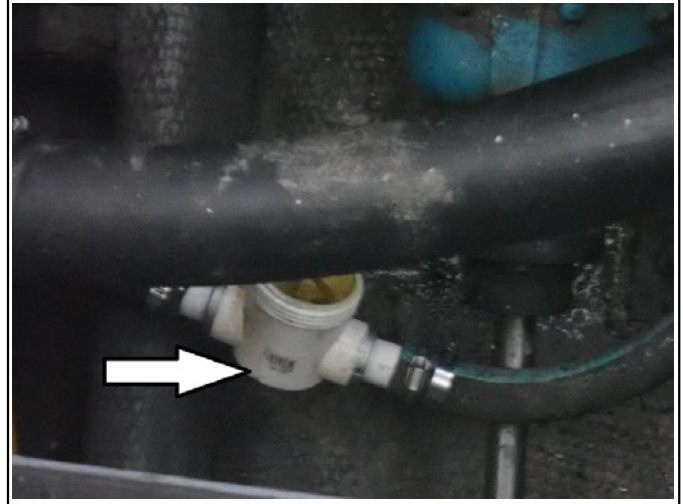
It is the opinion of the undersigned that this boat sustained damage due to: Port side engine strainer exploded due to freezing temperatures of ten degrees during the week of January 17th, 2024 causing the vessel to submerge up to the flybridge. The port engine strainer was clearly damaged due to freezing temperatures. The seacock was not closed to prevent this occurrence.

Port Engine Strainer/Cause Of Boat Sinking

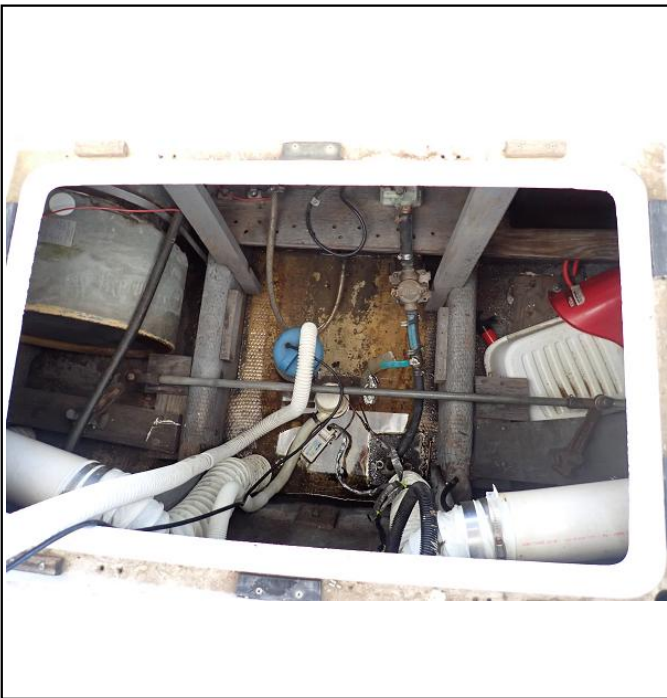
Note: The two bilge pumps that were sighted had remote auto float switches. The pumps could not be tested because the 12 volt power had been disabled. A submersible sump pump was also present present and in working order.

Sump Pump
