1999 37' Bayliner 3587 Aft Cabin Motoryacht

"Home Office"

Condition & Value Report of Marine Survey

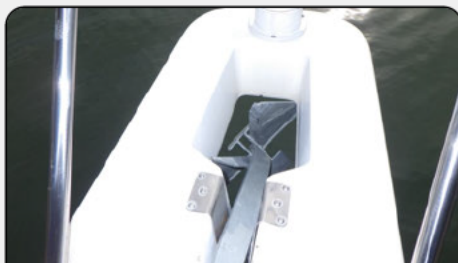
Finding A-6 Anchors

Photo 2: Note bend to port in the shaft as it enters the center of the anchor.

Since the extent of damage to the main anchor cannot be ascertained it is recommended that both anchors are replaced, sized to the size of boat and purpose for which they are required.

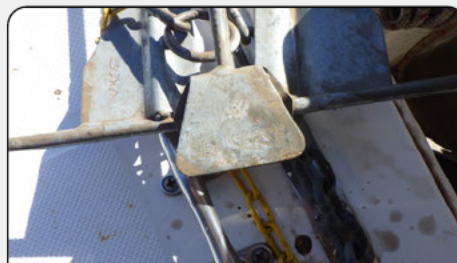
Photo 3: Reserve Seasense SS10.

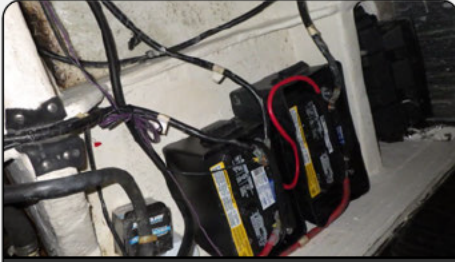
Finding A-7 Batteries

Photo 4: Port battery bank. No covers on terminals and on stbd battery a small black wire is sighted under large cable. No overcurrent protection within 7 inches.

Investigate further/trace, and service, repair or replace as necessary.

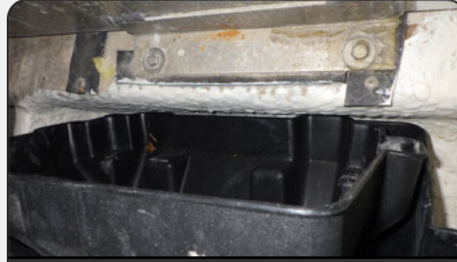
Photo 5: Battery cover not in place

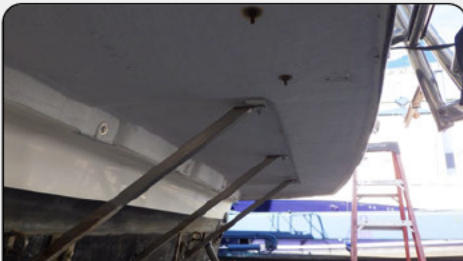
The FRP swim platform appeared to have been repaired / replaced recently. It was solidly attached to the transom with no movement discernable when "bounced". Moisture readings were low and no delamination was detected by percussion testing. The swim ladder was mounted securely on a plate of unidentified material. Two fasteners attaching the swim ladder were rusted and need replacing.

Photo 6: Rusted fasteners need replacing with marine grade stainless steel

Replace with marine grade stainless steel fittings.

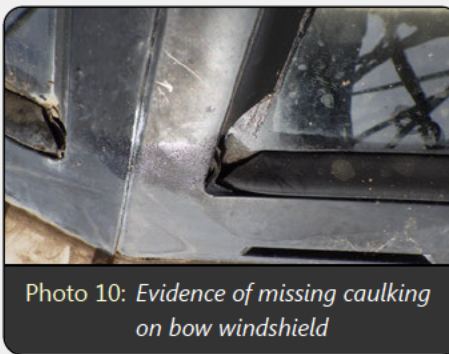
Tinted and tempered, fixed windshield and sliding side windows. Caulking was missing in several areas, but drain holes were free. Insects had built nests under the winter windshield cover.

Photo 10: Evidence of missing caulking on bow windshield

The area is currently protected by the windshield cover and the fiberglass has no significant moisture but, when the cover is removed it is the surveyor's opinion that water intrusion is highly likely. This will lead to potentially serious fiberglass issues. Strongly recommend to replace / repair the trim and recaulk as required as a matter of urgency.

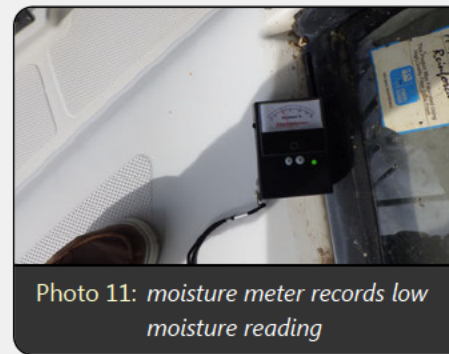
Photo 11: moisture meter records low moisture reading

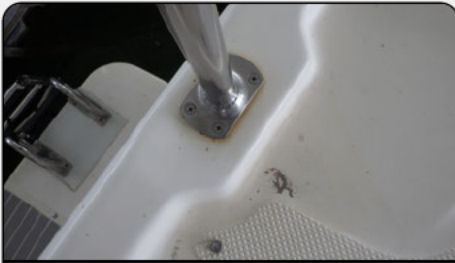
Photo 12: *corrosion on the stanchion mounting.*

Investigate further, and repair in accordance with accepted marine practice as necessary.

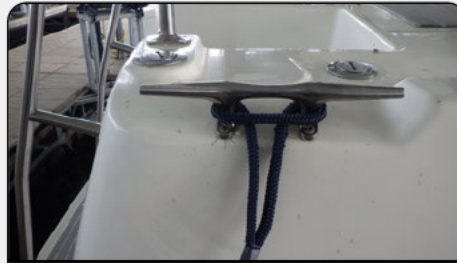
Finding B-6 Cleats

Eight off 10" Stainless steel horn type cleats were sighted. They were all securely mounted. The aft stbd cleat showed cracking around its fitting. No significant moisture was detected, and it was sound and holding the vessel to the dock with no sign of fatigue.

Photo 13: *Cleat showing signs of cracking.*

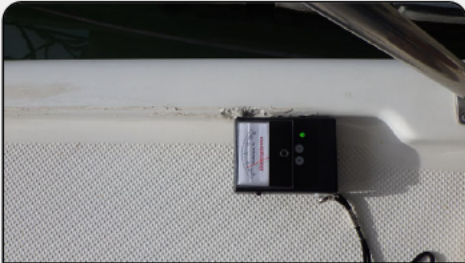
Molded fiberglass toe-rails were part of the deck's layout. An amateur repair was sighted but the moisture reading was low. In the same area slight gelcoat crazing was sighted.

Photo 17: *Poor quality repair but no water intrusion at this stage. Note slight crazing on toe rail on LHS of photograph*

Investigate further/monitor, and repair in accordance with good marine practice as necessary.

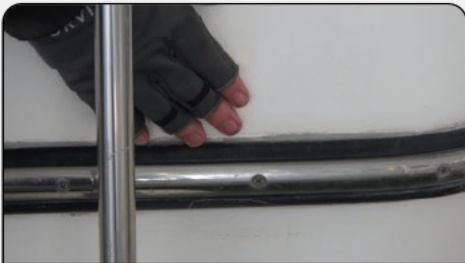
Finding C-6 Rub-Rails

Photo 18: *Exposed gelcoat area.*

Refinish, refit the rub rails, as necessary.

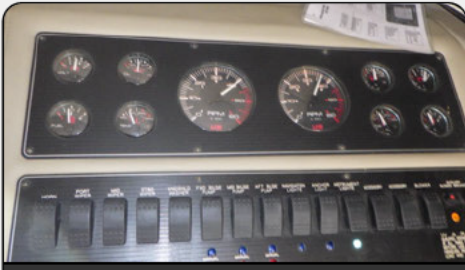
Finding C-9 Engine Instrumentation

Photo 20: Instrument display during trial run. Note rev difference between engines.

Investigate further/trace, and service, repair or replace as necessary.

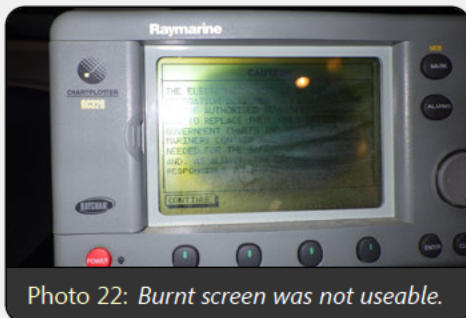
Photo 22: Burnt screen was not useable.

Replace the equipment.

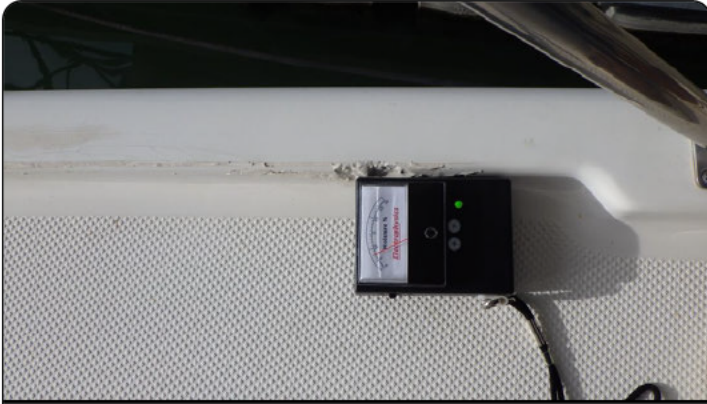
Photo 31: *poor quality repair to toe rail but moisture level low*

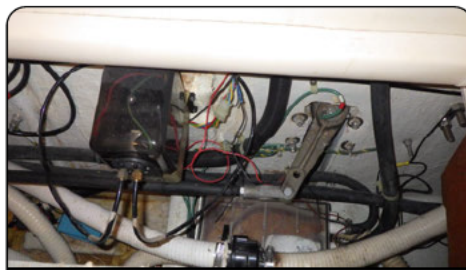
Photo 34: *Steering hydraulics again but note good bonding wire to lever and general cleanliness*

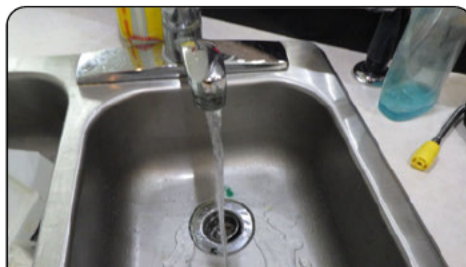
Photo 37: *Evidence of freshwater flow and good condition of the faucet and sink*

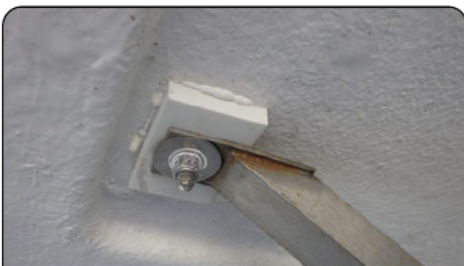
Photo 48: Support for "new" swim platform. Note some corrosion
